## THE EVALUATION OF THE FUNCTIONAL AND ECOLOGICAL STATUS OF THE TIRASPOL SECTION OF THE DNIESTER PROTECTION EMBANKMENT

Vladimir Fomenko and Sergey Filipenko

**Abstract:** The article discusses the contemporary problems connected with the Dniester's embankment protection of the Tiraspol segment. A special attention is paid to the probable scenarios of the under-flooding of the city area. A set of measures is suggested for the prediction, protection and overcoming of the flooding consequences.

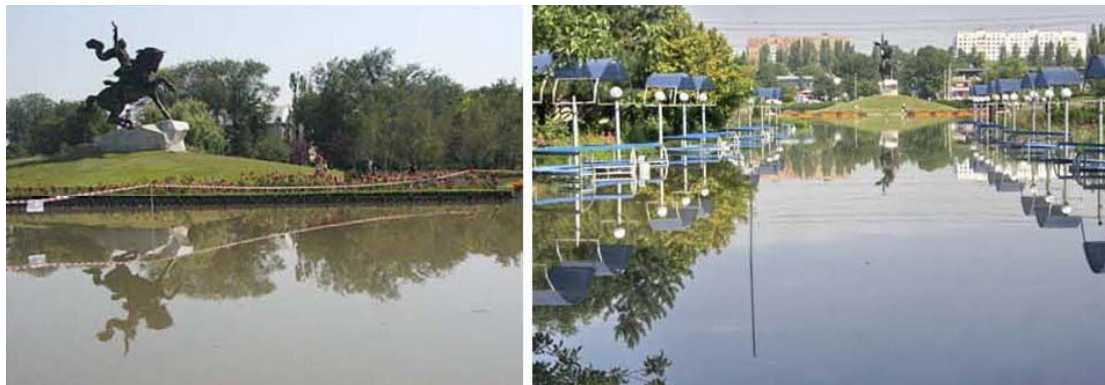
On July 28, 2008 in Transnistria was declared an emergency due to flooding that occurred as a result of heavy rains and melting snow in the Carpathians. As a result, the Western Ukraine, Transnistria and Moldova suffered. In Transnistria, were flooded more than 800 homes, and about two thousand people were evacuated (Figs. 2 and 3).

**Figure no. 2** Flooding in 2008, the Central Square of Tiraspol

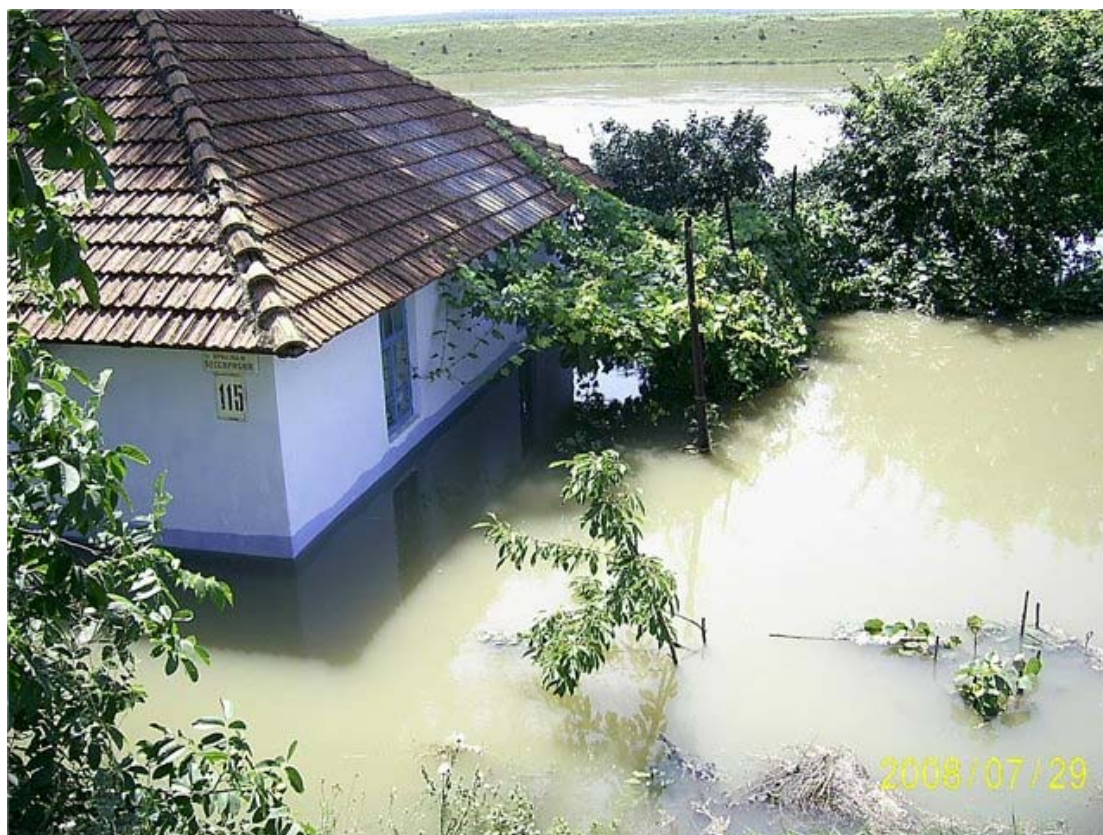
**Figure no. 3** Country house in one of the Transdnestrian villages in the flood zone, 2008
